13th International Scientific Conference on Sustainable, Modern and Safe Transport
(TRANSCOM 2019), High Tatras, Novy Smokovec – Grand Hotel Bellevue,
Slovak Republic, May 29-31, 2019

Analysis of the cause of the girth gear tooth fracture occurrence at the bucket wheel excavator

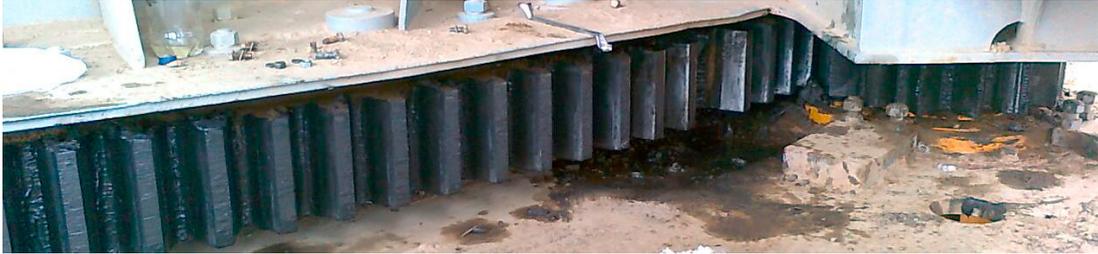
Based on the calculated number of cycles of the load changes until the tooth fracture, it can be concluded that the fracture occurred due to fatigue load and because there was an initial crack in the broken tooth base. In Figs. 2 and 3 are shown gears, the pinion and the girth gear and the fracture surface the broken tooth and the broken tooth. Analysis

Fig. 2. Appearance of the girth gear and the pin for rotation of the excavator's upper structure.

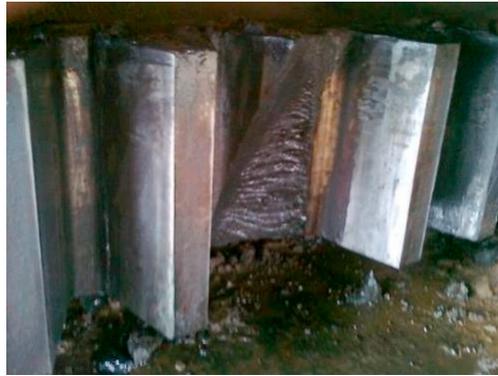
of the broken tooth fracture surface clearly shows that the very small portion of the tooth was loaded in fatigue (smooth fracture surface of the girth gear) and that the much larger portion was subjected to static fracture (the rough fracture surface of the girth gear), Fig. 3.

Based on the fracture surface appearance and calculated total number of the fatigue loading (stress) cycles of the girth gear tooth, $N = 3.6 \times 10^4$, one can conclude that the fracture occurred due to existence of the initial crack in the tooth base, which originated during the girth gear manufacturing.

Fig. 3. Appearance of the fracture surface of the girth gear at the broken tooth spot.

Analysis of the fracture mechanics parameters confirmed that the girth gear tooth fracture was caused by the initial crack existing in its base, which originated during the gear's manufacturing.
