THEORETICAL-EXPERIMENTAL FRACTURE ANALYSIS OF A RESPONSIBLE MACHINE PART TEORIJSKO-EKSPERIMENTALNA ANALIZA LOMA ODGOVORNOG MAŠINSKOG DELA

Originalni naučni rad / Original scientific paper

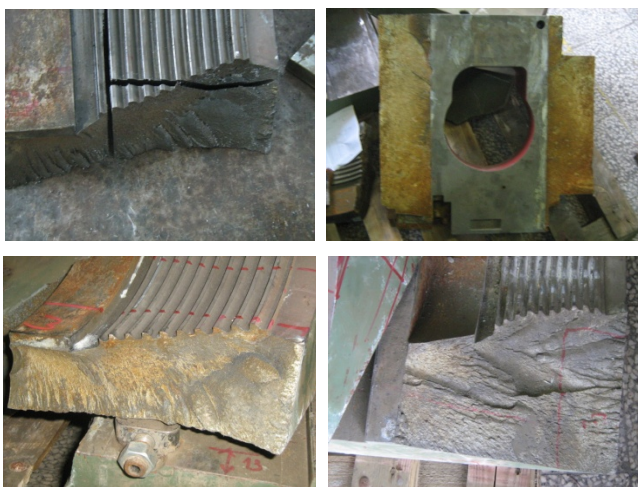
In the analysed case, three possible main causes for the breaking of this part are given (Fig. 2):

1. Bad design solution of the part.
2. Errors during mechanical processing and heat treatment.
3. Errors in the primary production of steel.

Figure 2. Fracture surface appearance of the considered part.

- Hardness, as measured according to /11/, equals 317 HB;
- Depth and hardness of the nitride layer;
- Visual investigations, based on the appearance of the fractured surface, it can be concluded that it belongs to scale II for estimated laminarity of the fracture, to a degree 5 (wooden fracture).

- Depth, quality and hardness of the nitride layer satisfies prescribed requirements;
- Macro-survey of the fracture surface: appearance of the fractured surface belongs to scale II for the estimate of fracture laminarity, degree 5 (wooden fracture);

- Semi-finished forged pieces that have laminar fracture of degrees 4 and 5 should be rejected as scrap;
- All investigations are done on samples taken from the forged piece;

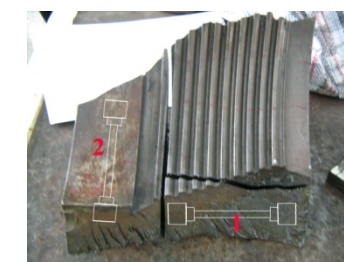
Figure 3. Sampling locations on the broken part.
Slika 3. Mesta uzimanja uzoraka sa havariisanog dela

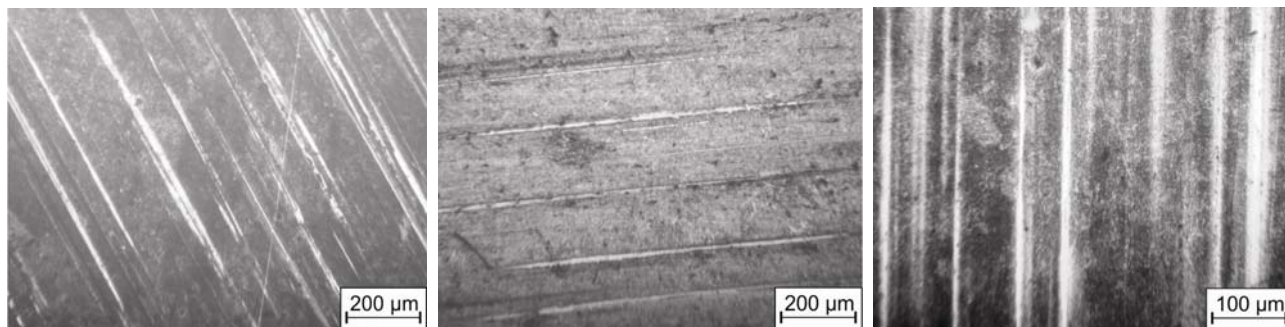
Phosphorus segregation – bright stripes/Segregacija fosfora – svetle trake

Figure 5. Microstructure of metallographic slits taken from different zones of fracture.
Slika 5. Mikrostruktura metalografskih izbrusaka pripremljenih iz različitih zona preloma

- Microstructure – interphase temper structure with prominent white stripes (Fig. 5, etched in 2% nital). Etching in Oberhofer reagent of about ten slits taken directly from the fractured surface shows segregation of phosphorus, presented in Fig. 5;

- Microstructure satisfies the prescribed requirement for the tempered steel;
- Presence of phosphorus segregation within the microstructure of ten samples taken from different places within the fracture zone point to the fact that the material is of unacceptable quality, since the inhomogeneity of this type in material increases its brittleness.

Finally, we must emphasize again, that this work points out the importance of performing additional tests, besides standard chemical, mechanical and metallographic tests which would establish whether the substituting material complies with all the prescribed requirements. Here we especially recommend destructive and non-destructive additional tests to be done, e.g. those which would check the presence of non-metallic inclusions, their shape, size and distribution in the material, for they are the cause of this particular steel part fracture.
