AN EXAMPLE OF REPARATORY SURFACE WELDING OF THE MINING MACHINE VITAL PART

Dušan Arsić¹, Ružica Nikolić^{2,*}, Vukić Lazić¹, Srbišlav Aleksandrović¹, Ljubica Radović³,
Nada Ilić³, Branislav Hadzima²

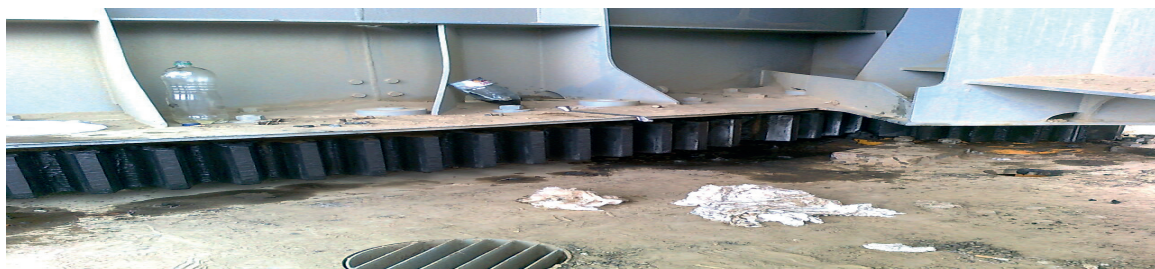
Figure 2 Appearance of the girth gear and the pinion for rotation of the excavator's upper structure

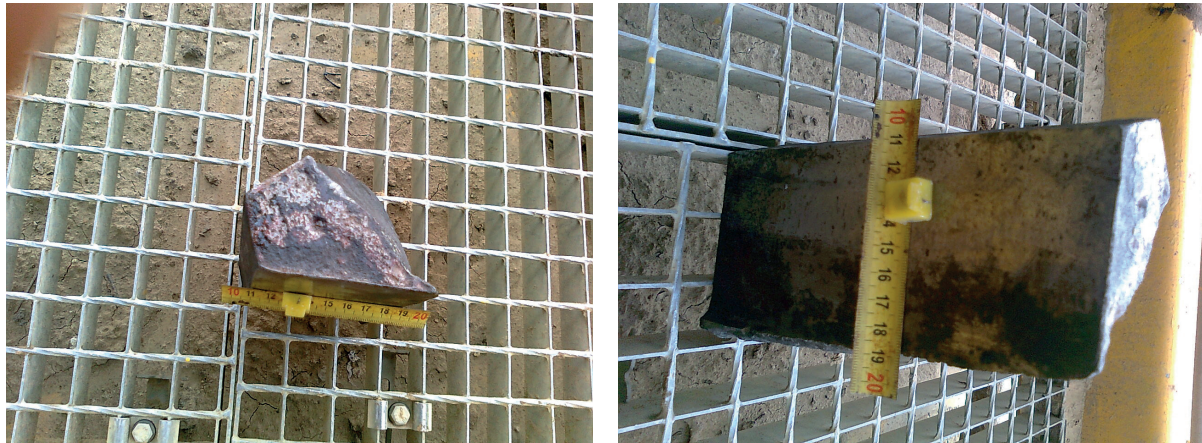
It was established, through analysis of the fracture surface that the fracture occurred during the fatigue loading and due to existence of an initial crack in the tooth base. That crack was created during the girth gear manufacturing and it was not detected prior to gear's mounting onto the BWE's structure.

Figure 3 Appearance of the broken tooth and its dimensions

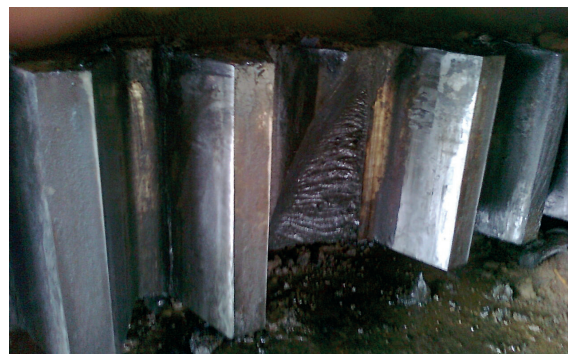
In Figures 2 to 4 are shown the gear, the broken tooth and the girth gear fracture surface, respectively. Analysis of the broken tooth fracture surface clearly shows that the very small portion of the tooth was loaded in fatigue (smooth fracture surface of the girth gear) and that the much larger portion was subjected to static fracture (the rough fracture surface of the girth gear), Figure 4.

Figure 4 Appearance of the girth gear fracture surface at the broken tooth spot

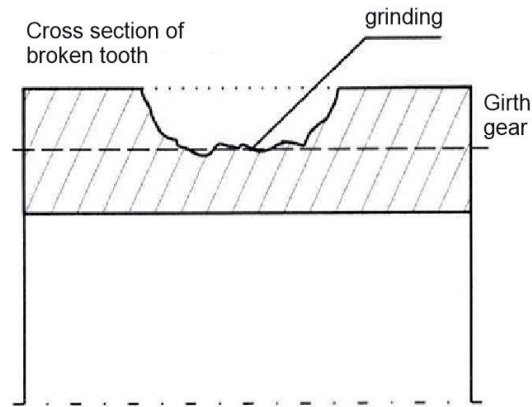
Figure 5 Schematic presentation of the girth gear cross section at the broken tooth spot

- The first measurement of the girth gear deformation (planarity test) by the appropriate template (measures' controller)
- Grinding of the fracture surface of the girth gear in the zone of the broken tooth by the corresponding grinders until the complete removal of all the unevenness and cracks, Figure 5

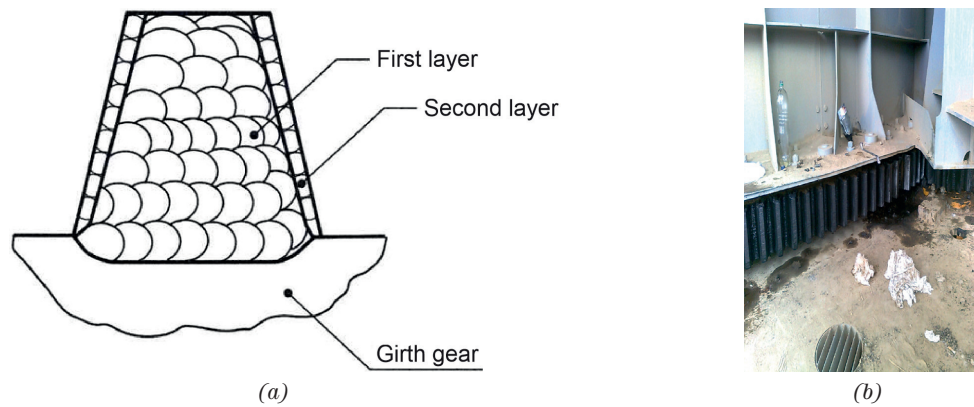
Figure 6 Order of the hard-facing layers deposition (a) and appearance of the new tooth (b)

The order of the hard-facing layers deposition and appearance of the new tooth are shown in Figure 6.

This hard-facing technology is completely defined by the presented preparatory and depositing operations. Depositing of the I layer was executed by the austenitic electrode marked E 18 8Mn B 22 [31], while the II layer was deposited by the basic electrode marked E 1-UM-300 (DIN 8555) [32]. The chemical composition of the E 18 8Mn B 22 electrode is presented in Table 4, mechanical properties of the weld metal in Table 5 and the chemical composition of the E 1-UM-300 electrode in Table 6.
