Miodrag Arsić, Zoran Savić  
 Institute for materials testing, Belgrade, Srbija  
 Srđan Bošnjak, Vlada Gašić  
 Faculty of Mechanical Engineering, Belgrade, Serbia  
 Dušan Arsić  
 Faculty of Engineering, Kragujevac, Serbia

# State Analysis of Components of the Damaged Structure and Integrity Evaluation of Braces at the Spreader A2Rs - B 5500.55 + BRs

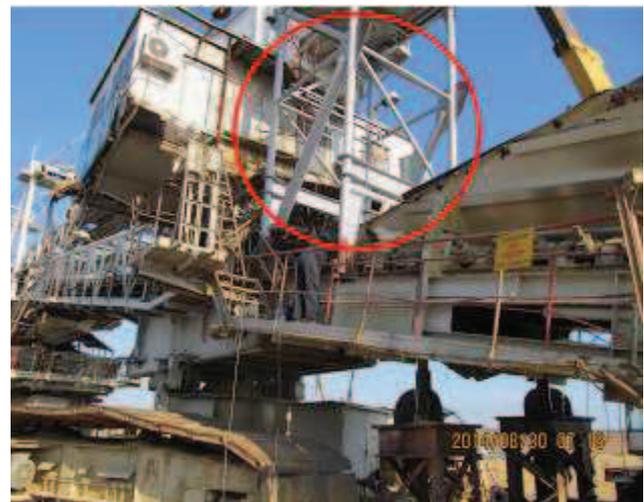
Spreader A2Rs - B 5500.55 + BRs before and after the breakdown is shown in *figure 1*. Breakdown of components of the vital lattice structure which occurred due to the uncontrollable sliding of the machine during the tempest which needed to be made from scratch is marked in *figure 1b* and shown in *figure 2*, while the state of braces in assembled condition is shown in *figure 3*. Some of the braces at which no damage was detected are shown in *figures 4a* and *4b*, while one of them at which the surface crack was detected on parent material, in the near proximity of the welded joint, is shown in *figure 4c*.

b) Appearance of the spreader after the breakdown

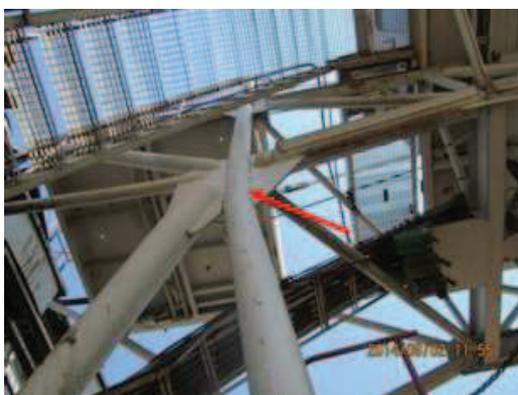
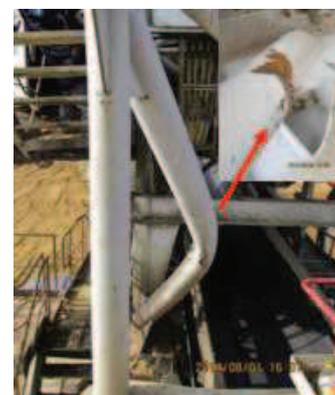
**Figure 2.-** Appearance of parts of the vital steel structure which needed to be made from scratch

a) Appearance of parts of the damaged vital steel structure

b) Appearance of a part of the damaged vital steel structure

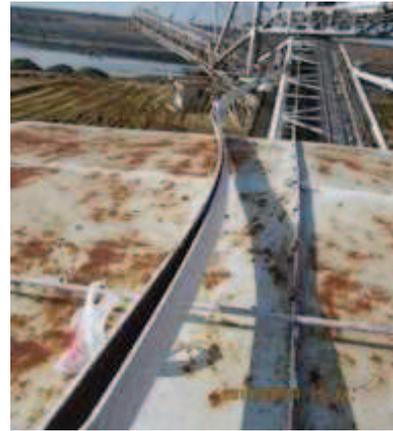
a) Appearance of the spreader after the breakdown

**Figure 3.-** Appearance of the condition of vital braces of spreader A2Rs - B 5500.55 + BRs before and after the breakdown

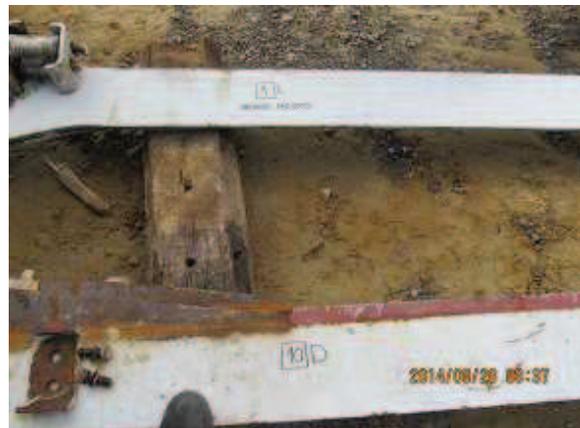
c) Right brace (10 D) with a surface crack

By visual testing [4] surface crack was detected at parent material of one of the braces of the discharge boom, in the near proximity of the butt-welded joint, which was confirmed by penetrant testing, *figure 4c*.

On the basis of the analysis of results of performed tests it was determined that the integrity of a brace at which the surface crack was detected is not threatened, which could be said about the spreader as a whole after the installation of the new segment of steel structure, *figure 6*.

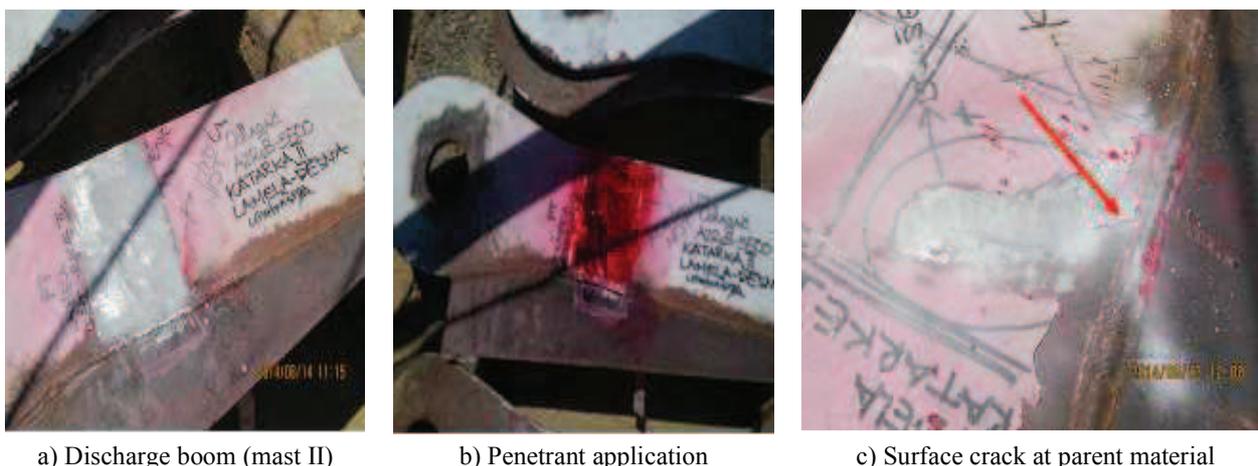
**Figure 5.- Appearance of the process of penetrant testing**

Results of a penetrant test [5], performed at parent material of one of the braces of the discharge boom, in the near proximity of the butt-welded joint, which was also subjected to the test, are shown in *figure 5*. The crack was approximately 1 mm deep and was removed by fine grinding. Report nr. PT – 025/14 [6].

c) Surface crack at parent material

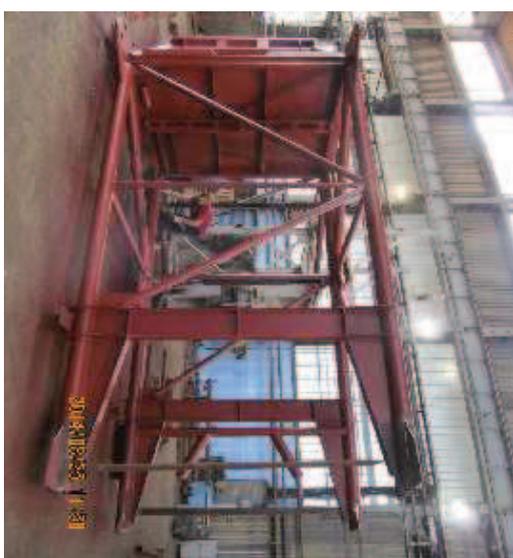
a) Appearance of the new segment of steel structure

On the basis of qualitative analysis of the new segment of steel structure (*figure 6a*) and its successful installation (*figure 6b*), as well as taking into account the condition of all braces after the completion of the assembly of the cutting boom and discharge boom, the spreader has been restored into functional condition and put into service.

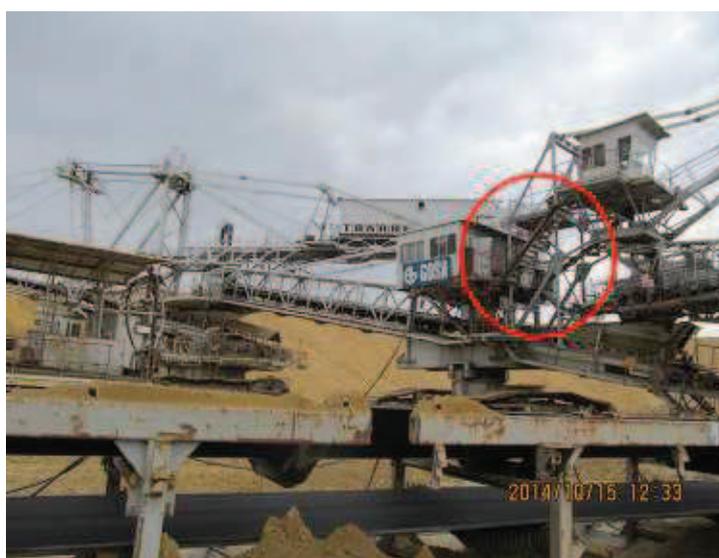
b) Spreader after the repair of steel structure and installation
