REPARATORY HARD FACING OF WORKING PARTS MADE OF MARTENSITIC STAINLESS STEEL IN CONFECTIONARY INDUSTRY

D. ARSIĆ*, V. LAZIĆ, S. ALEKSANDROVIĆ, M. BABIĆ,
D. MILOSAVLJEVIĆ, M. ĐORĐEVIĆ, N. RATKOVIĆ

*Faculty of Engineering, University of Kragujevac, 34000 Kragujevac, Serbia
E-mail: dusan.arsic@fink.rs*

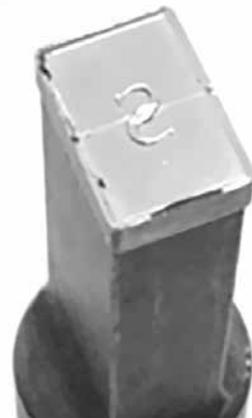
Fig. 1. Damaged shape punch

When the sugar mass is sub-cooled the pressure increases. Fatigue wear occurs as a result of frequent changes in the loading direction, when movable and fixed parts come into contact during forward and backward movement of the tool. Worn shape punch is shown in Fig. 1.

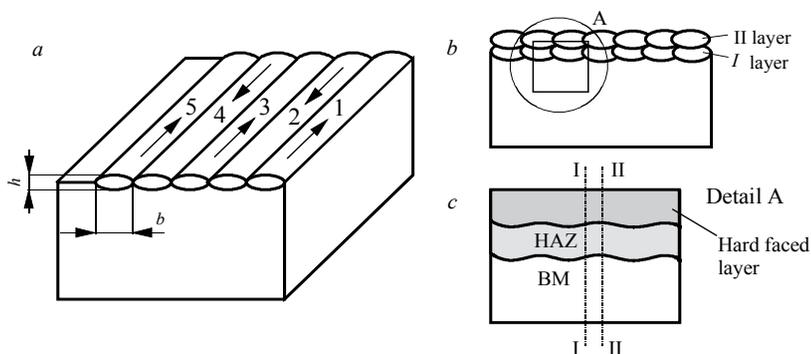
Fig. 2. Order of hard faced layer deposition: *a* – 1 layer, *b* – 2 layers, *c* – metallographic sample (block) (Ref. 4)

and used for metallographic investigations and hardness measurements. The third shape punch was hard faced and cut out into a block used for tribological investigations (Fig. 2*c*). Hard facing was carried out in two layers as shown in Fig. 2*b*. The height of one layer was 1.2–1.5 mm and the width was 3–4 mm (Fig. 2*a*). The TIG-hard facing parameters hard facing of the models and tribological investigations are given in Table 5.

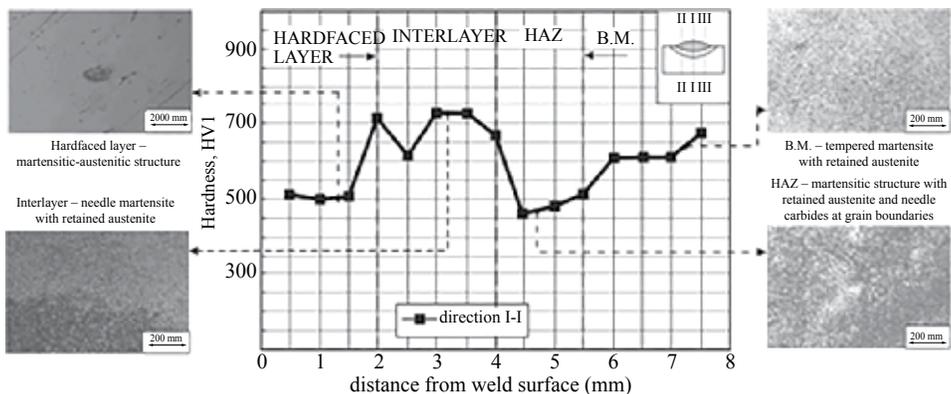
Fig 4. Distribution of hardness and microstructure of characteristic zones – Sample I

structure with little residual martensite. The HAZ is about 5 mm wide, not especially prominent, and it has interphase quenched and tempered structure. The hardness distribution diagram shows that hardness decreases in the HAZ, which means that tempering and not hardening occurred. This is highly favourable because it reduces the possibility of cracking.

Hardening in the HAZ would affect the desired mechanical properties of the repaired tool. Hardness distribution and microstructures of the characteristic zones are given in Fig. 4.

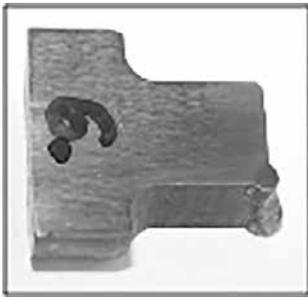
Fig. 5. Hard faced shape punch – Sample II (BM-Č4850, FM-Č4850)

Metallographic investigations and hardness measurements – Sample II. Macro appearance of the shape punch hard faced using TIG procedure is shown in Fig. 5. The depth of penetration was about 0.8 mm while the height of the hard faced layer was approximately 2.2 mm. There were neither cracks nor flaws on the cross-section, which means that the bonding between the hard faced layer and the base material was firm. The base material microstructure was estimated as small-grained interphase quenched and tempered structure. The hard faced layer has martensitic structure with needle-shaped carbides at metal grain boundaries with a lot of residual austenite. The transient zone is easily visible and dominated by interphase structure with little martensite. The HAZ is about 5 mm wide, it is not especially prominent and it has interphase quenched and tempered structure. The hardness distribution diagram shows that hardness increases in the HAZ, which is explained by hardening of the base material particularly in the transient zone. Hardness distribution and microstructures of the hard faced layer zones are given in Fig. 6.

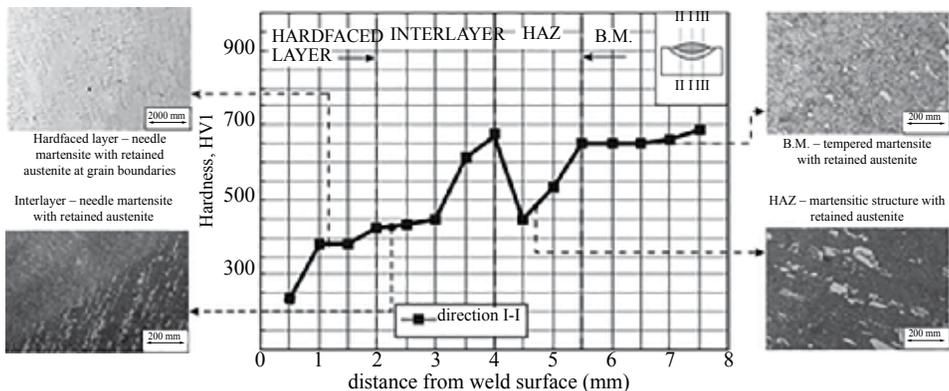
Fig. 6. Distribution of hardness and microstructure of characteristic zones – Sample II

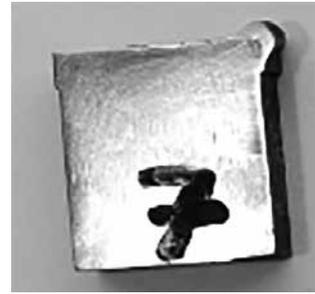
Fig. 7. Hard faced shape punch – Sample III (BM-Č4850, FM-Castolin EUTALLOY BRON-ZOCROM 10185)

Metallographic investigations and hardness measurements – Sample III. Macro appearance of the shape punch repaired using gas-powder hard facing is shown in Fig. 7. The height of the hard faced layer was approximately 1.3 mm. There were neither cracks nor flaws on the cross-section, which means that the bonding between the hard faced layer and the base material (BM) was firm. The base material microstructure was estimated as small-grained homogenous interphase quenched and tempered structure. The hard faced layer has austenitic structure with small-grained needle-shaped martensitic structure at austenite grain boundaries. The transient zone is visible because the base and filler materials have not mixed. The HAZ is not particularly wide, but the metal of interphase quenched and tempered structures have clearly increased in size. The hardness distribution diagram shows that hardness increases in the HAZ, which is explained by hardening of the base material. The increase is not significant, therefore it will not have a considerable effect on the output properties of the hard faced layer. Hardness distribution and microstructures of the hard faced layer zones are given in Fig. 8.

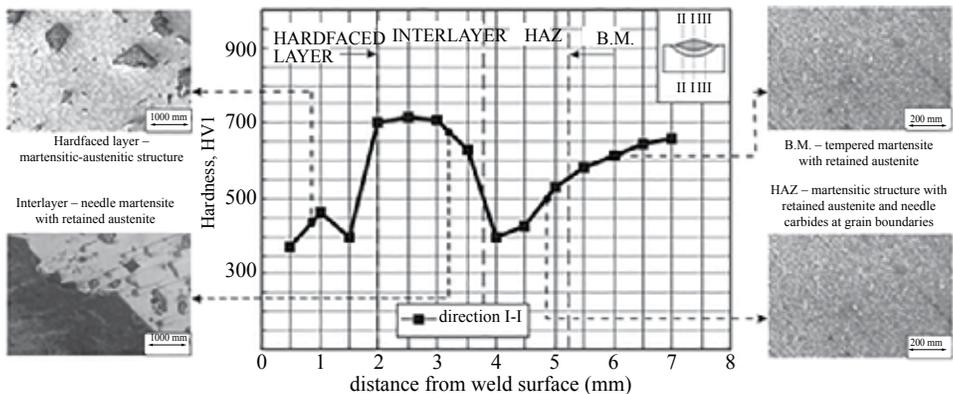
Fig 8. Distribution of hardness and microstructure of characteristic zones – Sample III

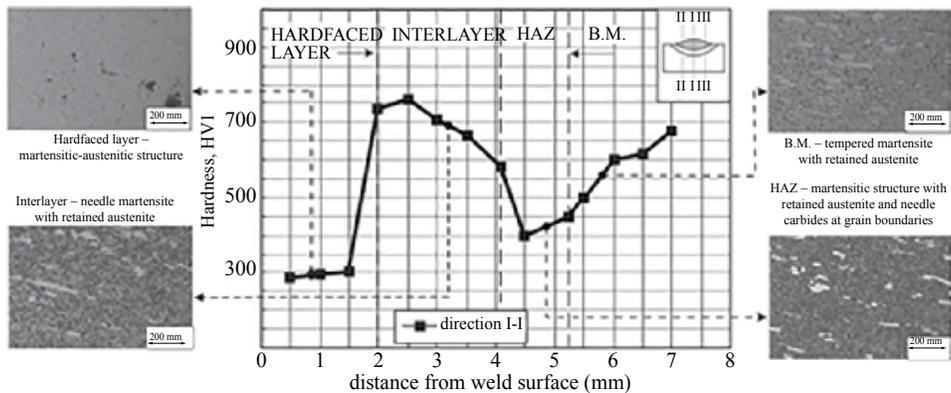
Fig. 10. Distribution of hardness and microstructure of characteristic zones – Sample IV

to ensure good properties of the hard faced layer, i.e. of the hard faced part. The base material microstructure was estimated as small-grained homogenous inter-phase quenched and tempered structure. The hard faced layer has austenitic structure with small-grained needle-shaped martensitic structure distributed at austenite grain boundaries in a net-like pattern. The transient zone is easily visible because the base and filler materials have not mixed. The HAZ is about 5 mm wide, but it is not very prominent although it has been treated with aqua regia^{4,9,10}. The hardness distribution diagram shows that hardness increases in the HAZ, which is explained by hardening and change in the structure of the base material due to the input heat. The increase in hardness

is not significant, so it will not have a considerable effect on the properties of the hard faced part. Distributions of hardness and microstructure of hard faced layer zones are given in Fig. 10.

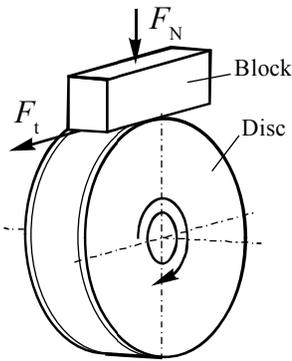
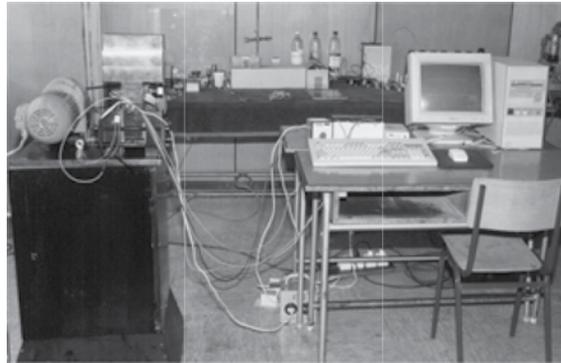
Fig. 11. Tribometer TPD-93 and other measuring equipment for tribological testing⁴

Tribological tests. Tribological investigations were carried out for a block-on-disk contact, on a tribometer TPD-93 (Fig. 11) installed at the Faculty of Mechanical Engineering in Kragujevac. The aim of these investigations was to evaluate the resistance to wear of the base materials and deposited layers^{1-7,14,16}. Prismatic samples (four from the hard faced layer and one from the base material) were prepared for tribological tests (6.5×15×10 mm). During the tests, the line block-on-disk contact was realised. The outer variables of the tested samples were contact forces, sliding speed and the lubricant. Motor oil Nisotec SE15-40 was used for the tests.

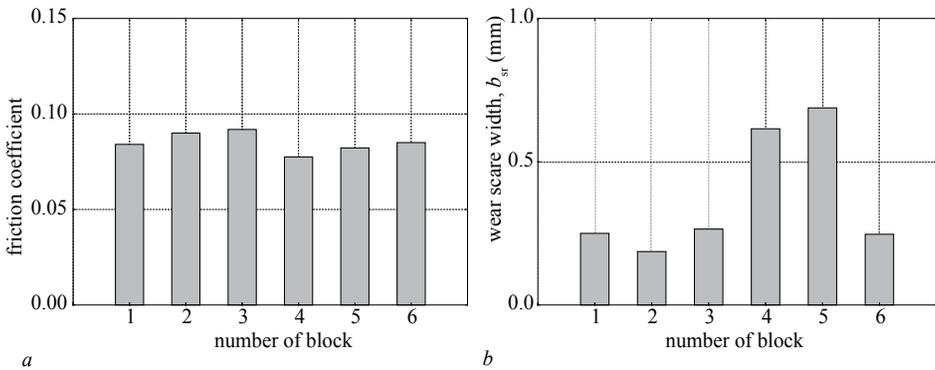
Fig. 12. Diagrams of mean values of the friction coefficient (a) and wear scar width (b)

Prior to investigations, topography of the disc and block surfaces was measured on the computer measuring system Talysarf 6. Then, the contact was realised. The normal force of $F_N = 50$ N and the sliding speed of $v_{sl} = 0.5$ m/s were adopted. After the contact of 60 min, the wear scar width was measured. This way the tribological characteristics of the blocks were determined. The samples were marked as shown in Table 7. Firstly, the friction coefficient was measured for all the samples. After each test, the samples were ground again in order to enable the same conditions throughout the experiment. Then, the wear scar width was measured and the roughness profile was established^{8-10,14}. The wear scar width was measured using a universal microscope UIM-21, with magnification of 50 times while the roughness was measured and the wear scar profile determined on Talysarf 6. Figure 12a gives a summary graph (histogram) of the mean values of the friction coefficient and Fig. 12b displays a histogram of the mean values of wear scar width for tribological couples. Also, Fig. 12a shows

that all the materials have approximately the same mean value of the friction coefficients ranging from $\mu = 0.08409$ (block 4) to $\mu = 0.09192$ (block 3). As seen in Fig. 12b, the block 2 (FM Č4850) has the smallest mean wear scar width $b_{sr} = 0.1865$ mm, while the block 4, whose friction coefficient is the lowest, has the largest wear scar width $b_{sr} = 0.614$ mm. It is noticed that the base material has the lowest friction coefficient but the largest wear scar width $b_{sr} = 0.68$ mm, which indicates the possibility of production hard facing of new parts.

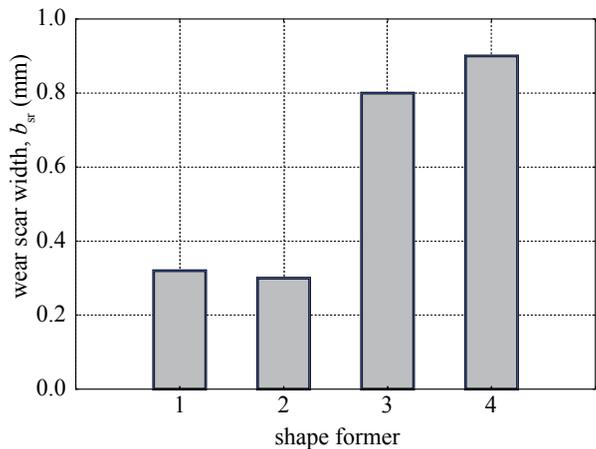
Fig. 13. Histogram of distributions of the mean values of wear scar width

service life, there was no new shape punches mounted together with the repaired ones. Whilst in service, geometry and wear scar width of the shape punches were periodically checked. After the repaired shape punches had been used for nine months wear scar width was measured again. The results of these measurements are shown in Fig. 13.

In all four cases, the hard faced shape punches not only proved to be more resistant but some of them also had a few times longer service life compared to the new ones. This increase in resistance is the result of a more favourable microstructure of the hard faced zones and a better bonding between the hard faced layer and the base material.
