# Application of Non-Destructive Testing for Condition Analysis, Repair of Damages and Integrity Assessment of Vital Steel Structures

**Keywords:** bucket-wheel excavator, welding, non-destructive tests, repair, structural integrity

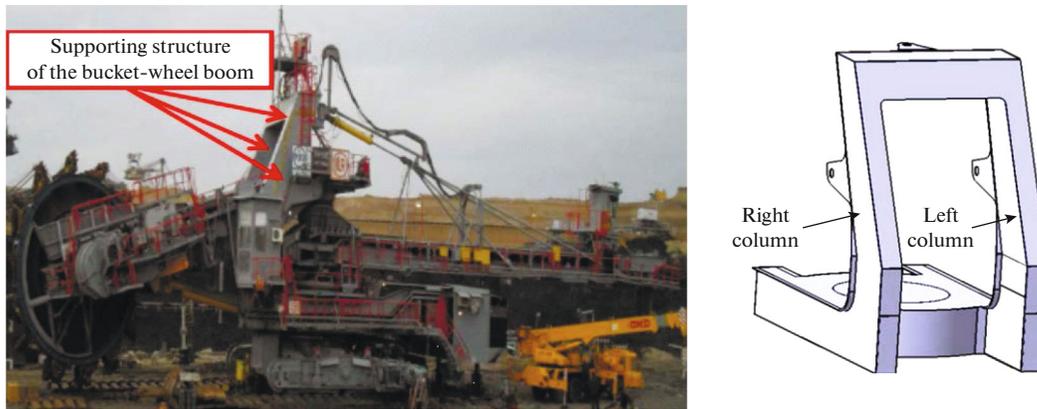
**Fig. 1.** Bucket-wheel excavator SchRs 800 in the open pit mine “Kostolac”—Serbia and model of the vital structure of the bucket-wheel boom (rotating platform and P frame).

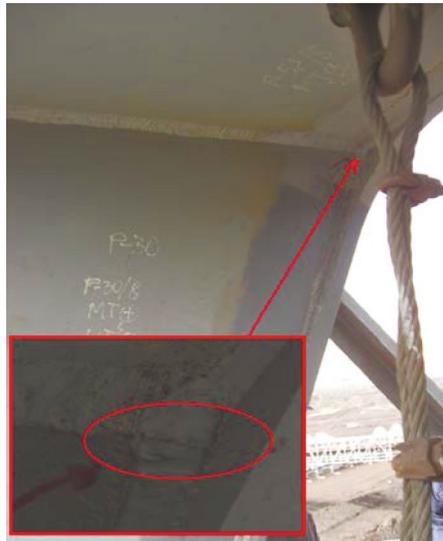
**Fig. 3.** Cracks on the surface of column fillet welded joints—right side (crack lengths up to  $L = 20$  mm).

Areas with damages in lower and upper regions of the vital welded structure of the bucket-wheel boom were detected by visual testing [14] (Fig. 3). Appearance of damages detected through penetrant testing [15] on welded joints at the right side of the structure is presented in Fig. 4, while the appearance of damages detected on parent material and weld metal at the left side of the structure is presented in Figs. 5 and 6. The appearance of one of the damaged components of the left column of the P frame structure at which it is necessary to perform the repair through the use of newly produced components is presented in Fig. 7, while its interior is presented in Fig. 8.

On the basis of determined values of the overall factor of decrease of fatigue strength ( $k_{rf}$ ) it can be concluded why cracks originate and propagate in the areas with stress concentrators on the rotating platform (Figs. 6, 8) and in the areas of welded joints at the vital structure of the bucket-wheel boom (Figs. 3, 4, 7, 9).

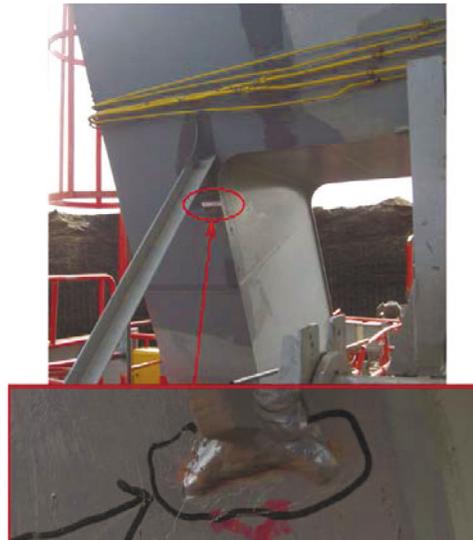
**Fig. 4.** Crack on the surface of fillet welded joints, left side of the column—detail c (crack length  $L = 40$  mm).

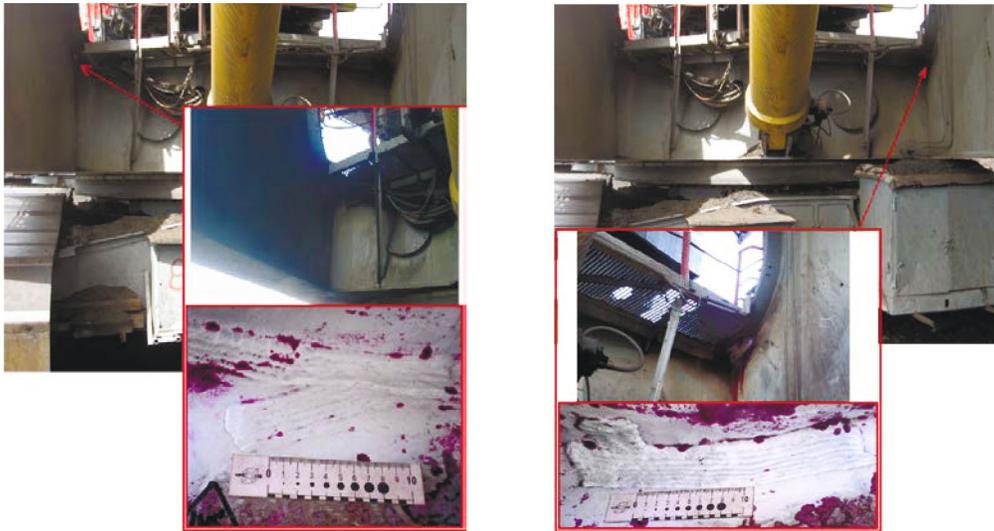
**Fig. 5.** Damages at parent material of the rotating platform and welded joints detected during penetrant testing.

Stress concentrators, generally, appear at locations with radiuses inadequately defined during the design process (Figs. 3 and 5) and at welded structures (Figs. 2–4, 6 and 7). Welded structures depend on a large number of technological, metallurgical, structural and exploitation factors. It should also be men-

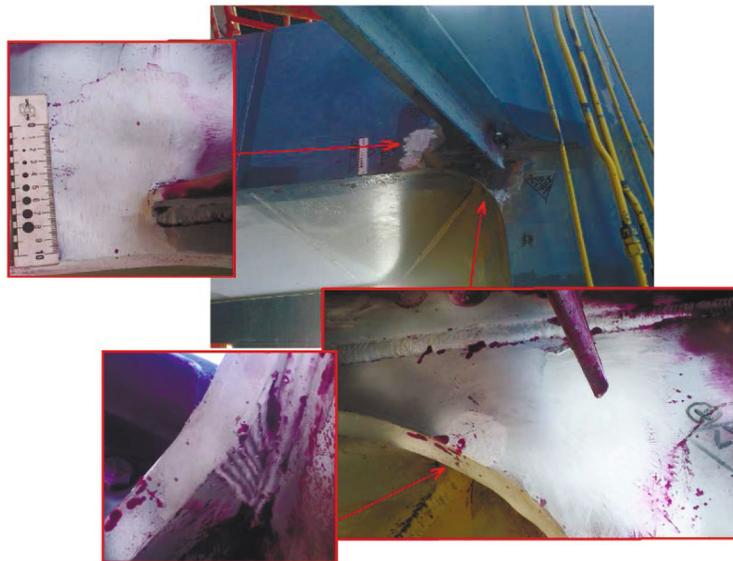
**Fig. 6.** Damages at parent material of the P frame and welded joints detected during penetrant testing (left side—Fig. 3, detail *c*).

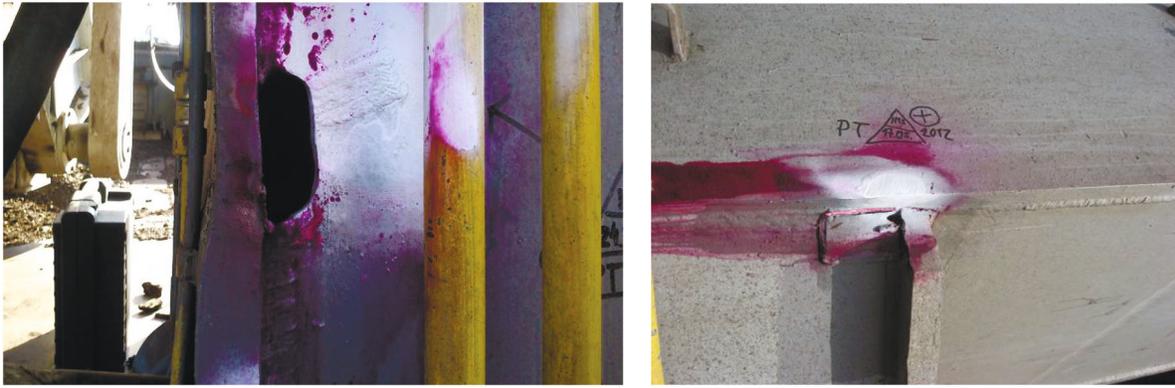
Fig. 7. Damages at parent material and welded joints of the P frame—left side.

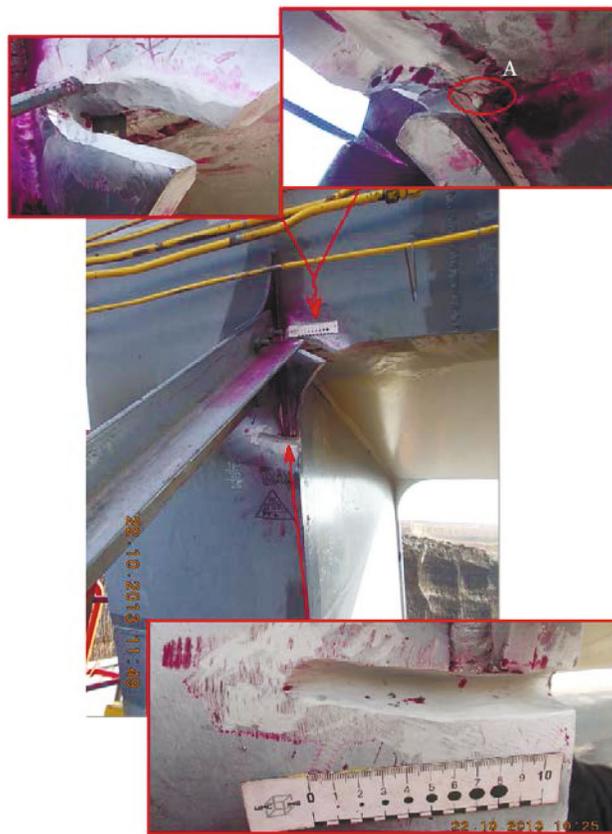
Fig. 8. Grinded fillet weld at the left column of the P frame (detail A at Fig. 10).

A few examples that refer to the preparation of components that belong to the vital structures of the P frame and rotating platform for repair welding are shown in Figs. 8–11.

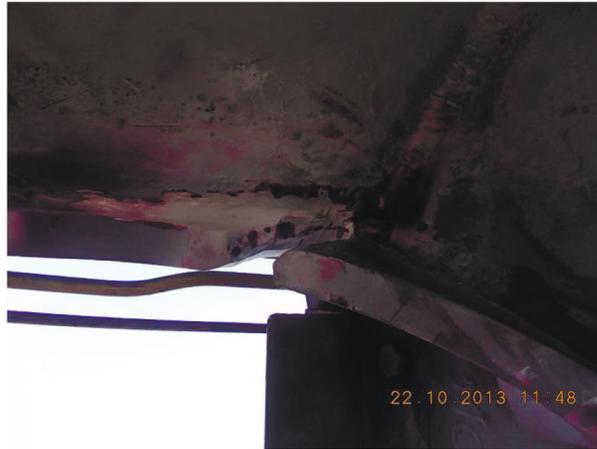
**Fig. 9.** Grinded fillet weld at the right column of the P frame (detail B at Fig. 10).

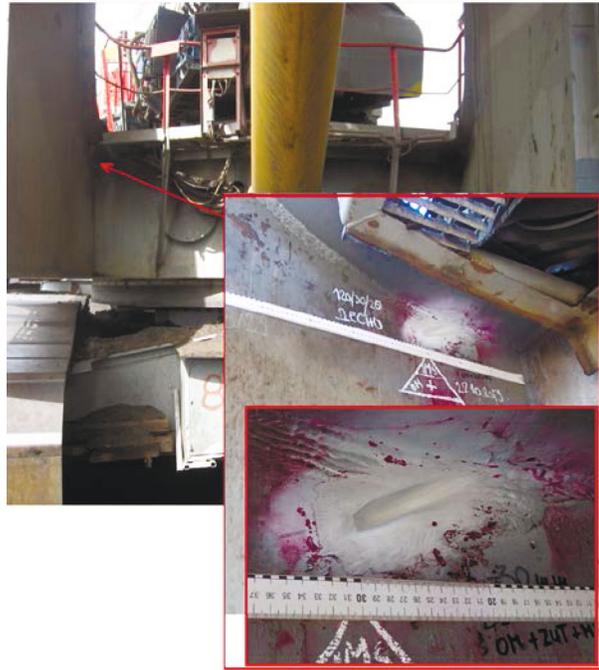
**Fig. 11.** Grinded section at the right side of the rotating platform.

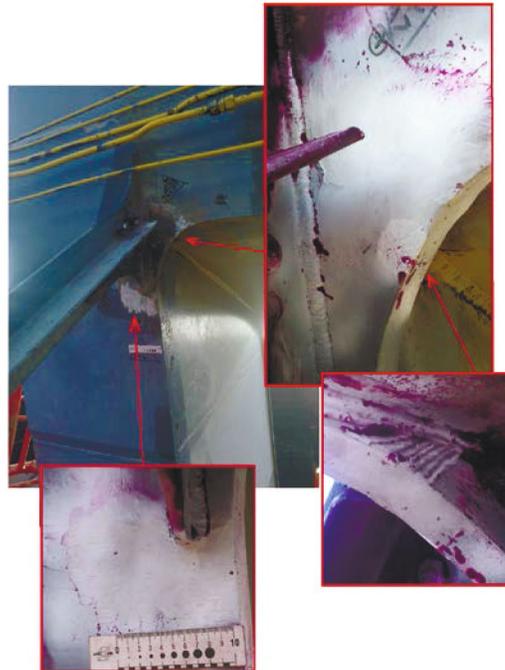
**Fig. 17.** Examined repair welded joint at the right side of the structure of the rotating platform.

Ultrasonic testing was carried out in zones at the structure of the left column of the P frame where the damages have been repaired, Fig. 15 [17], while penetrant testing that was executed at the structure of the rotating platform is presented in Figs. 16–18.

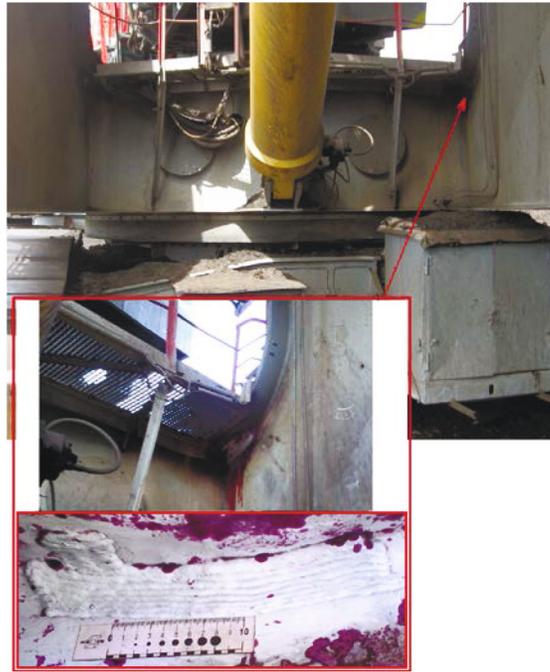
Fig. 18. Examined repair welded joint at the left side of the structure of the rotating platform.
