Miodrag Arsić, Zoran Savić  
 Institute for materials testing, Belgrade, Srbija  
 Srđan Bošnjak, Vlada Gašić  
 Faculty of Mechanical Engineering, Belgrade, Serbia  
 Dušan Arsić  
 Faculty of Engineering, Kragujevac, Serbia

# State Analysis of Components of the Damaged Structure and Integrity Evaluation of Braces at the Spreader A2Rs - B 5500.55 + BRs

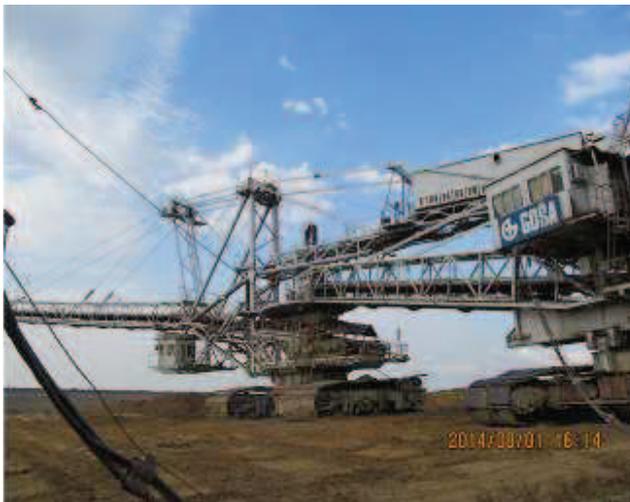
a) Appearance of the spreader before the breakdown

**Figure 1.-** Appearance of the spreader A2Rs - B 5500.55 + BRs before and after the breakdown

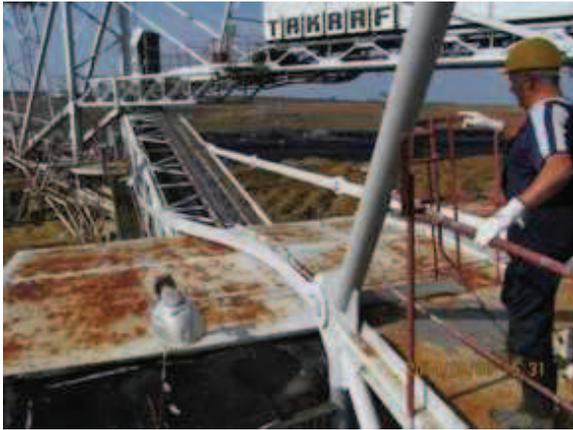
a) Appearance of the spreader before the breakdown

**Figure 3.-** Appearance of the condition of vital braces of spreader A2Rs - B 5500.55 + BRs before and after the breakdown
