International Conference on Manufacturing Engineering and Materials, ICMEM 2016,  
6-10 June 2016, Nový Smokovec, Slovakia

## Selection and analysis of material for boiler pipes in a steam plant

The problems of a material selection for making the boiler pipes in a responsible steam plant and the technology for their welding are considered in this paper. The boiler is screened, complex, radiating energetic plant, with the natural water circulation in the hanging steel structure. Based on the legal regulations, the mandatory periodic reparation of the most important components is performed. This is why the check of mechanical properties, for the used and new materials for eventual replacement and building-in was done, as well as the check of the prescribed reparation procedures. The components that were in exploitation were checked, since their properties change with time. Checking consisted of testing the tensile material properties at room and elevated temperatures, measurements of hardness and analysis of materials' microstructures. Besides the experimental tests, the numerical modeling and analysis of the workload of the fluid transporting pipes was conducted. In that way it wa

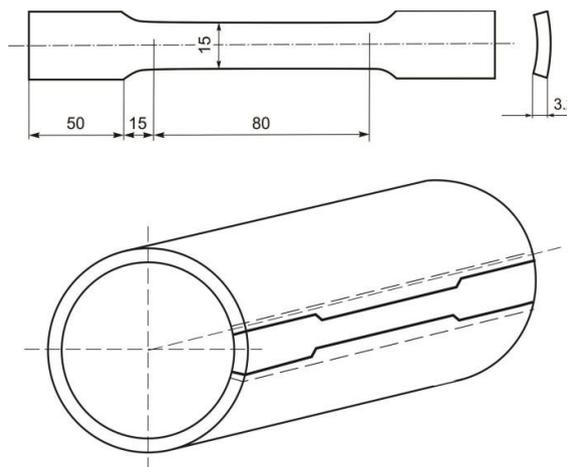
For the pipes of the larger diameter ( $> \text{Ø} 30 \text{ mm}$ ) and the smaller thickness, the proportional sample was prepared, taken from the pipes wall, of sizes  $l_0 = 11.2 \sqrt{a \cdot b}$ , mm, ( $a$  – wall thickness, mm;  $b$  – sample width, mm), Fig. 1.

Fig. 1. Sample sizes and place from where the sample was taken

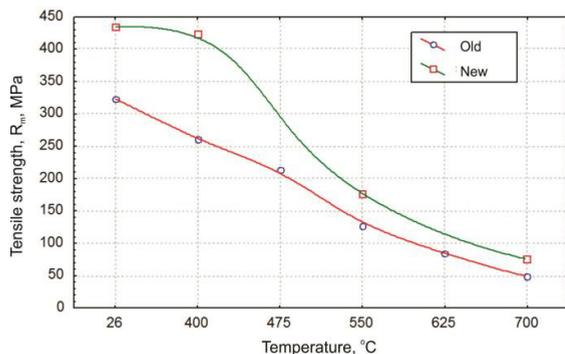
Fig. 2. Tensile strength variation in terms of temperature

The tensile strength and the yield stress in terms of temperature are given in Figs. 2 and 3.

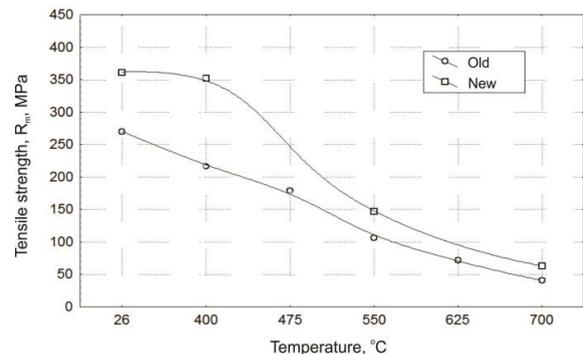
Fig. 3. Yield stress variation in terms of temperature

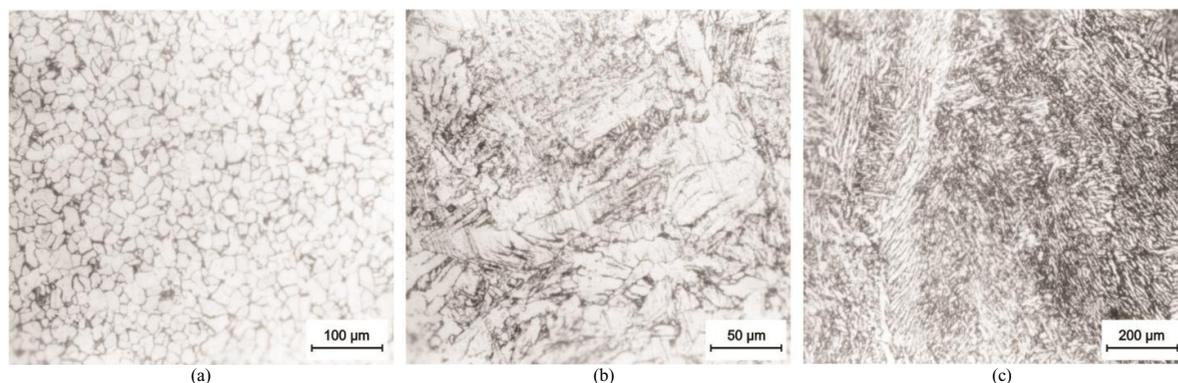
Fig. 4. Microstructure of the characteristic zones of the boiler pipe welded joint: (a) BM; (b) HAZ; (c) WM

Taking into account the wall thickness, weldability of the base metal, energy abilities of the welding procedure, geometrical complexity of the structure and economic justifiability of executing such a structure, the gas welding procedure was selected. The butt joint was chosen (V-notch) and the welding is done in two passes (according to the wall thickness). Welding was done without either previous or post heat treatment due to very good weldability of the base metal, what is not usual in majority of cases, since materials for this type of plants manufacturing usually require heat treatment to obtain the favorable micro structure and hardness, [20]. The characteristic microstructures of the welded joint's zones and the limit values of the measured hardness are presented in Fig. 4 and Table 4.

Welded joint zone	Base metal (BM)	Heat Affected Zone (HAZ)	Weld metal (WM)
Microstructure	Widmanstatten (Martensite + residual austenite)	Coarse grained Ferrite + Pearlite	Fine grained Ferrite + Pearlite
Hardness, HV	234-321	159-193	131-159

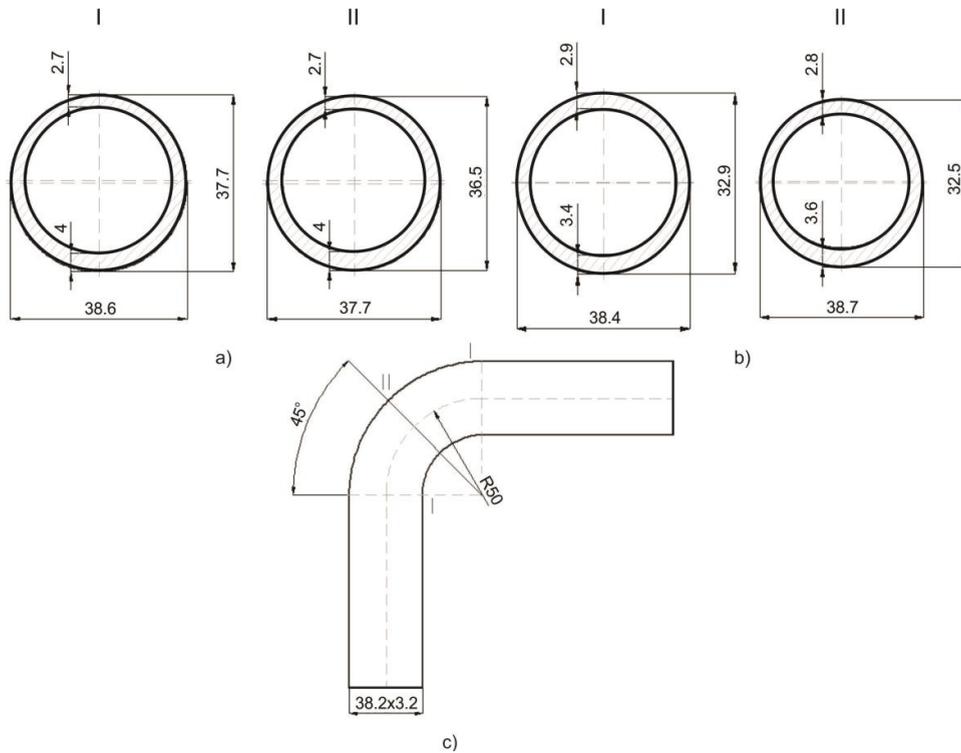
Fig. 5. Sizes of the characteristics cross sections: (a) old pipe; (b) new pipe; (c) Characteristic sections at the pipe bent at 90°

Sizes of the characteristic cross sections are presented in Figure 5. Linear interpolation between the characteristic cross sections was applied for obtaining the volumes used for generating the 3D finite elements used in the FEM analysis.

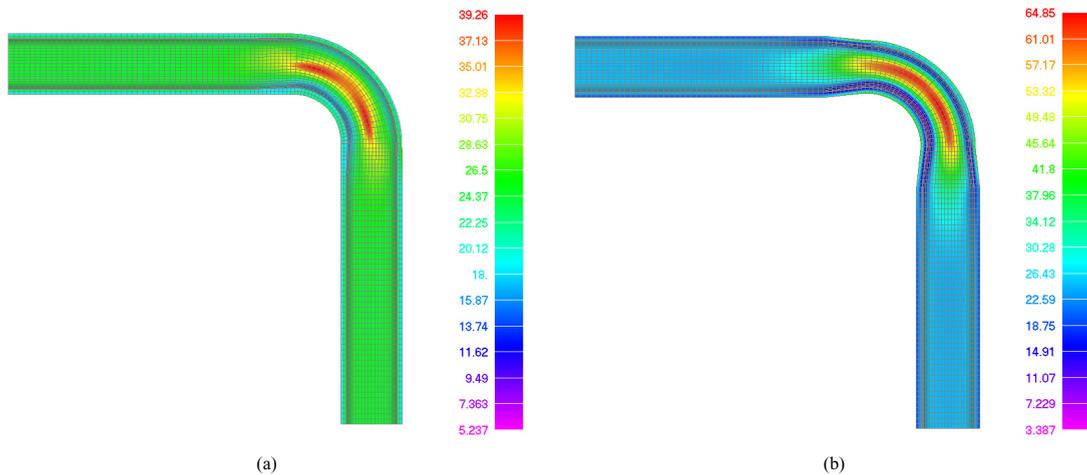
Fig. 6. Stresses due to pressure and the temperature field – the inside appearance: (a) the old pipe; (b) the new pipe

In the case of the complex stress, the maximal effective stress for the old pipe was 39.26 MPa, while for the new pipe it was 64.85 MPa, and it appeared at the interior side of the pipe in the curved portion. It can be concluded that during the new pipes bending the unfavorable shape appeared, which caused increase of the maximal effective stress for 65 % with respect to the maximal effective stresses obtained for the old pipe. Since the adopted permanent time strength was  $\sigma_{M100000} = 97 \text{ MPa}$  at the calculation temperature of 425 °C, the obtained safety degree was 1.5 for the new pipes, while for the old pipes it was 2.47, which is way above the value for the new pipes.

The half of the pipe was used as the initial model for the FEM analysis. That was possible due to the planar symmetry and in that way the computation time was reduced. The boundary restrictions were set in such a way that the pipe could expand freely due to the thermal dilatations. The pipes were subjected to additional mechanical loading due to internal pressure, which in the operating conditions does not exceed the maximal value of 4.5 MPa. Obtained results and the maximal effective stress field at the interior pipe surface are presented in Fig. 6.
