Article

# Analysis of the Welding Type and Filler Metal Influence on Performance of a Regenerated Gear

**Abstract:** This paper presents the results of voluminous experimental investigations conducted to analyze the influence of the welding procedure on the performance of regenerated gears. Cylindrical spur gears were tested, both newly manufactured and regenerated, in two fundamentally different ways: by hard facing (surfacing) with the “hard” filler metal (DUR 600-IG) and with the “soft” filler metal (EVB2CrMo) with subsequent cementation and quenching. The regeneration procedures were defined and executed, while, subsequently, the microstructure and microhardness of the hard-faced layers were established and measured, followed by checking the durability of the hard-faced teeth flanks. Finally, techno-economic analysis was performed to establish the rationality of the conducted regenerations, i.e., the costs of regenerated and newly manufactured teeth were compared. Based on the results of the conducted investigations, it was possible to establish the influence of the welding type on the performance characteristics (primarily the service life) of the regenerated gears. For indi

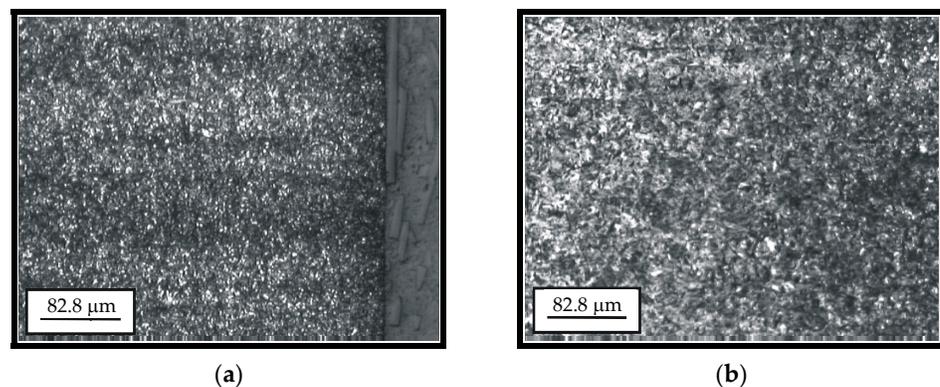
**Figure 1.** Microstructure of the cemented layer (a) and the transient zone (b).

The microstructure of the surface and subsurface layers (cemented layer and the core of the newly manufactured tooth) is presented in Figure 1a. The basic micro-constituent of the tooth cemented layer is the tempered martensite (dark areas in the figure). The smaller share of the retained austenite can also be noticed. In the surface zone, up to the depth of 0.2 to 0.3 mm, individual coarser carbides of the alloying elements are also present. Based on the appearance of the martensite needles, one can conclude that the material possesses a fine-grained structure, which points to the fact that the heat treatment process was properly conducted. Based on Figure 1b, one can see the difference between the microstructures of the cemented layer (the right-hand portion of the figure), microstructure of the transient zone (the middle portion of the figure) and microstructure of the core (the left-hand portion of the figure). Individual ferrite grains can be noticed in the transient zone (the coarser brighter areas), the number of which is much bigger in the core.

The metallographic investigations were conducted on the quantitative optical metallographic microscope POLYVAR-MET (Leica Reichart-Jung, Wien, Austria) with magnifications of 20 to 2000 times [26]. Figure 1 presents the microstructure of the cemented layer and of the transient zone of the hard-faced tooth.

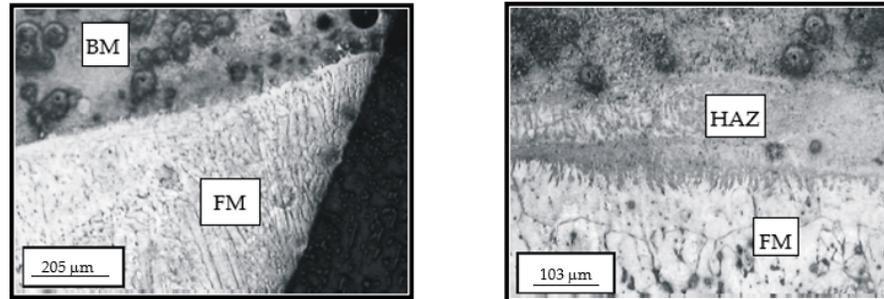
The microstructure of the tooth hard-faced by the TIG procedure and the filler metal DUR 600-IG in the argon protective atmosphere is shown in Figure 2a, while in Figure 2b, one can see the transition from the surfaced layer and the heat-affected zone. In the first figure, one can clearly notice the cast dendritic (stick-like) structure of the welded metal. The more prominent dendritic branches are present in the second surfaced layer, unlike the first layer where, due to the heat input during the second layer deposition, a smaller homogenization of the microstructure occurred. The dendrites' growth direction, with respect to the base metal (BM) and the first deposited layer, is perpendicular to the tooth surface.

**Figure 2.** The two-layer hard-faced tooth top – the base metal (BM) and the filler metal (FM) (a); the transient line between the filler metal (FM) and heat-affected zone (HAZ) (b).

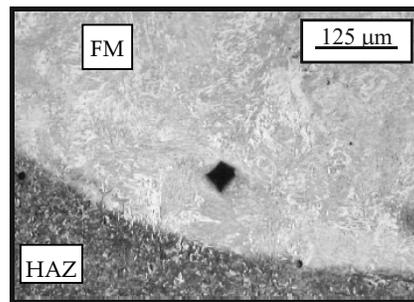
The microstructure of the cemented layer hard-faced with the filler metal EVB2CrMo is shown in Figure 3. The basic micro-constituent in the hard-faced layer zone is the tempered martensite. Based on the degree of etched material, one can conclude that there is a significant difference in the chemical composition between the FM and BM.

**Figure 3.** Microstructure of the transient zone from the cemented (bright field) hard-faced layer with the filler metal EVB2CrMo (FM) and the heat affected zone (HAZ) of the base metal (BM) (dark field)—state: hard-faced + soft annealed + cemented + heat treated.

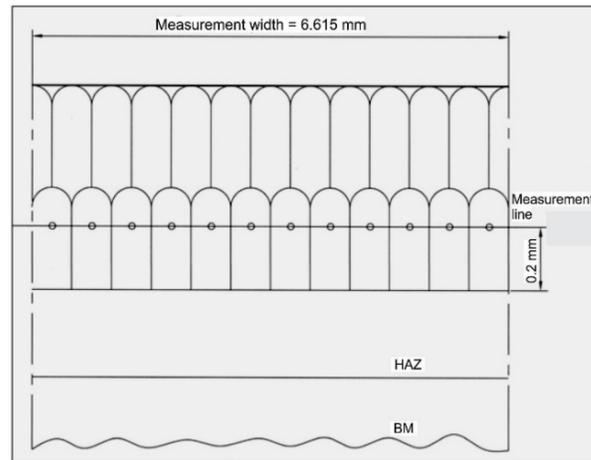
Since the exploitation characteristics of the hard-faced layer depend, to a great extent, on the size of dendrites within it, the dendritic crystals' width was measured on the optical microscope [26]. Those measurements were performed at a distance of 0.2 mm from the joint line, as shown in Figure 4. A total of 217 dendritic crystals were measured over the measurement width of 6.615 mm. The measurement results are presented in Table 2 and in Figure 5 [29].

**Figure 4.** The measurement line of the dendritic crystals' medium width.

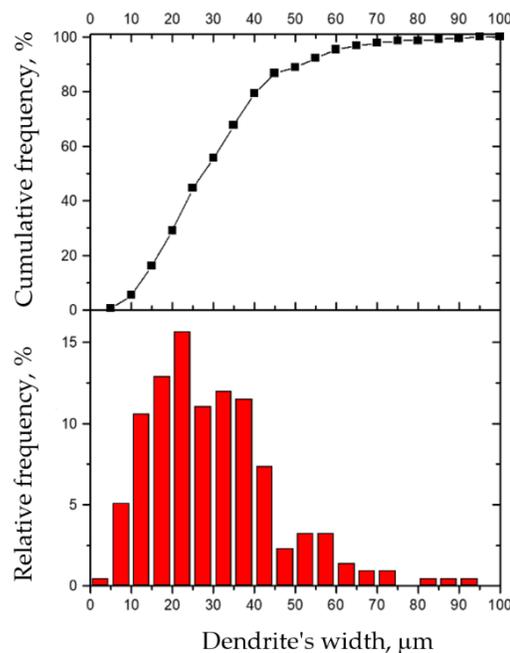
**Figure 5.** Cumulative and relative frequencies of dendrites' widths in the hard-faced layer deposited by the DUR 600-IG filler metal.

Based on the results presented in Table 2 and the diagrams in Figure 5, one can see that the average width of the dendritic crystals is  $30.48 \mu\text{m}$ . From the histograms, one can also notice that about 30% of dendrites have an average width of up to  $20 \mu\text{m}$ . About 45% of dendrites have an average width of up to  $30 \mu\text{m}$ , while about 80% have an average width of up to  $40 \mu\text{m}$ . A width of over  $60 \mu\text{m}$  is only achieved in about 3% of dendrites. The largest number of dendrites, i.e., 15.66% of them, have a width of 20 to  $25 \mu\text{m}$ , while 73.7% of dendrites have a width within the range of 10 to  $40 \mu\text{m}$ . Considering these results, one can conclude that the liquid bath during the hard facing had a relatively small volume and that the hard-faced layer possesses a fine-grained dendritic structure [26].

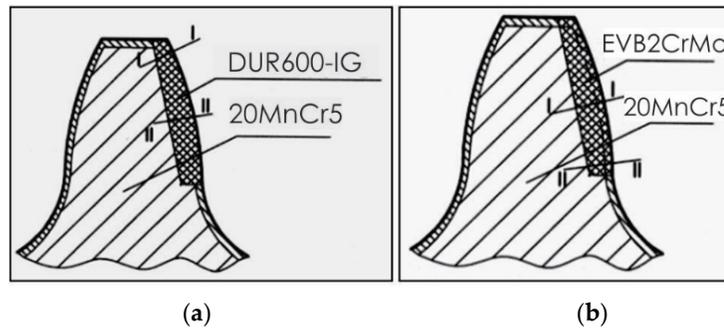
**Figure 6.** Microhardness measurements’ directions: tooth hard-faced with the DUR 600-IG FM (a) and tooth hard-faced with the EVB2CrMo FM (b).

The microhardness of the teeth, hard-faced by the TIG procedure with the filler metal DUR 600-IG, was measured in two directions, close to the top of the tooth and in the zone of the pitch circle, Figure 6a. Results are presented in Tables 3 and 4, as well as in diagrams

in Figure 7 [18]. For the tooth hard-faced with the filler metal EVB2CrMo, hardness was also measured in two directions, but in the zones of the pitch circle and the lowest area of the hard-faced layer, Figure 6b. Measurement results are presented in Tables 5 and 6, as well as in Figure 8.

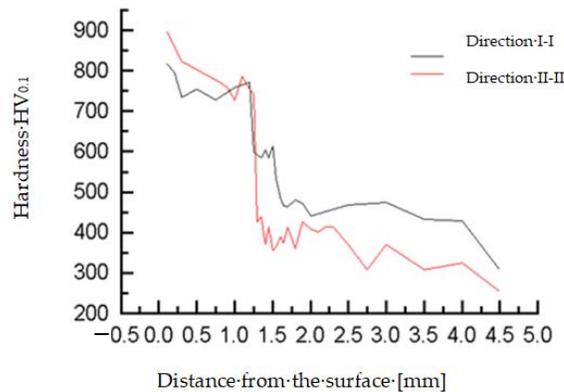
**Figure 7.** Microhardness measurement results for the tooth hard-faced with FM DUR 600-IG.

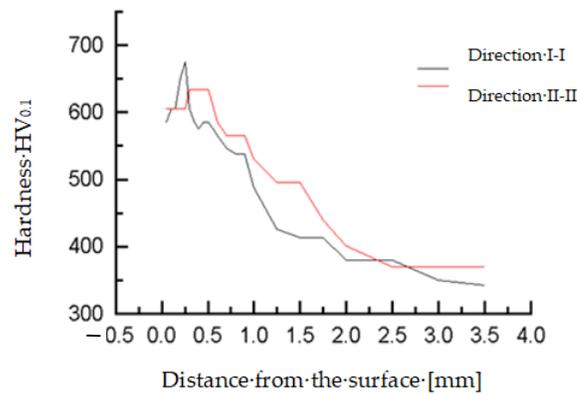
Figure 8. Microhardness measurement results for the tooth hard-faced with FM EVB2CrMo.

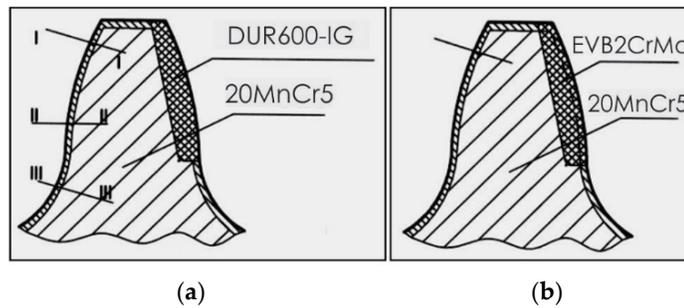
Figure 9. Microhardness measurements’ directions on the inactive tooth flanks: tooth hard-faced with the DUR 600-IG FM (a) and tooth hard-faced with the EVB2CrMo FM (b).

Besides the conducted investigations, the microhardness of the inactive tooth flanks of the regenerated teeth was measured, as well. For the sample hard-faced with the DUR 600-IG filler metal, hardness was measured in three directions, close to the tooth top (I-I), in the pitch circle zone (II-II) and at the tooth base (III-III), Figure 9a, while for the tooth hard-faced with the EVB2CrMo filler metal, hardness was measured only in the middle of the tooth, Figure 9b. Measurements’ results are presented in Tables 7–10, as well as in Figure 10.

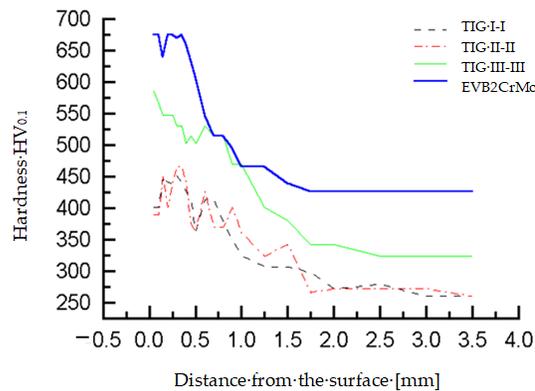
From the diagram in Figure 10, it is obvious that a hardness reduction occurs on the non-hard-faced surfaces of the teeth. From the presented results, one can easily notice that the largest hardness reduction occurs for the tooth hard-faced by the TIG procedure with the DUR 600-IG filler metal at the tooth head, while the tooth base (where there is much more material and which is further from the heat source during the hard facing) had the lowest hardness reduction. Such results were expected and are quite logical [26].

**Figure 10.** Microhardness measurement results on the inactive tooth flanks for the teeth hard-faced with FM DUR 600-IG and EVB2CrMo.

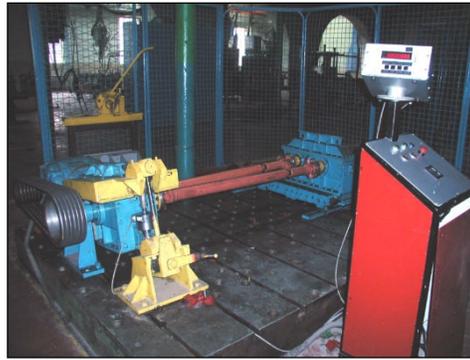
Investigation of the regenerated and newly manufactured teeth flanks' durability was performed on a closed-circuit device shown in Figure 11 [27]. The workload of 3000 Nm was introduced to gears gradually. In that way, failures were avoided.

**Figure 11.** Gears' testing device with closed circuit and reactive loader.

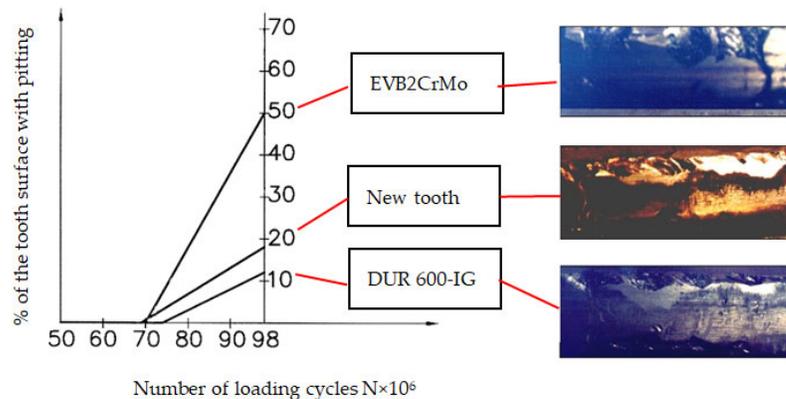
The appearance of the destructive wear, namely, the first pitting pits, was noticed after  $69 \times 10^6$  loading cycles for the newly manufactured teeth and for the teeth hard-faced with the EVB2CrMo filler metal after  $70 \times 10^6$  cycles. The longest operation prior to the appearance of the first pits was exhibited by teeth hard-faced by the TIG procedure and the DUR 600-IG filler metal, where the destructive pitting started after  $74 \times 10^6$  loading cycles. After  $98 \times 10^6$  loading cycles, the full duration of tests, for newly manufactured teeth, 18% of the most endangered tooth surface was covered with pitting; for the tooth hard-faced with the EVB2CrMo filler metal, the attacked area was about 50 %; and for the tooth hard-faced by the TIG procedure, this was only about 12 %. Analyzing the operation time until the first appearance of the destructive pitting of the regenerated and newly manufactured teeth produced the diagram shown in Figure 12.

**Figure 12.** Destructive pitting development rate.

Assuming that 5 % of the teeth working surfaces being affected by pitting are a criterion for interruption of the gears' working capacity (i.e., the wear limit), the operating time of the gears regenerated by the appropriate welding method ( $t_r$ ) was determined from the diagram shown in Figure 12. The operation time (service life) of the new gear, until reaching the limit wear, is  $t_n = 1510$  h.
